INSPECTION REPORT

MY AMADEUS

21072

BodhiNautic team was requested to inspect 7 inflatable fenders from MY AMADEUS.

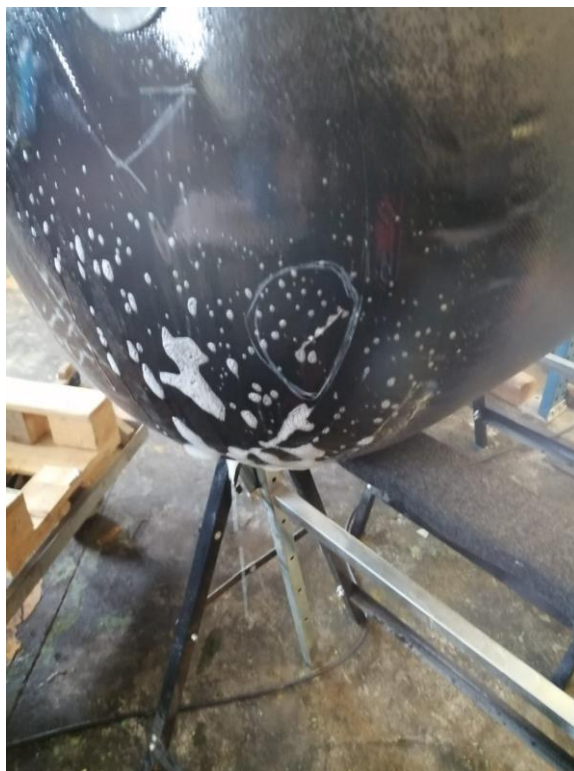
Fender 1 (Diameter 62 x 122cm) – Bad conditions, air leaking through glued seams

All the fenders with air leaking problems are coming from glue aging, so the reparation it doesn't make sense, as we can reinforce and area but there are meters of glued seams which they could give future problems... By other hand the reparation could be more costly than a new low quality fenders itself...

We highly recommend to acquire new fenders PVC thermosealed or Hypalon ones

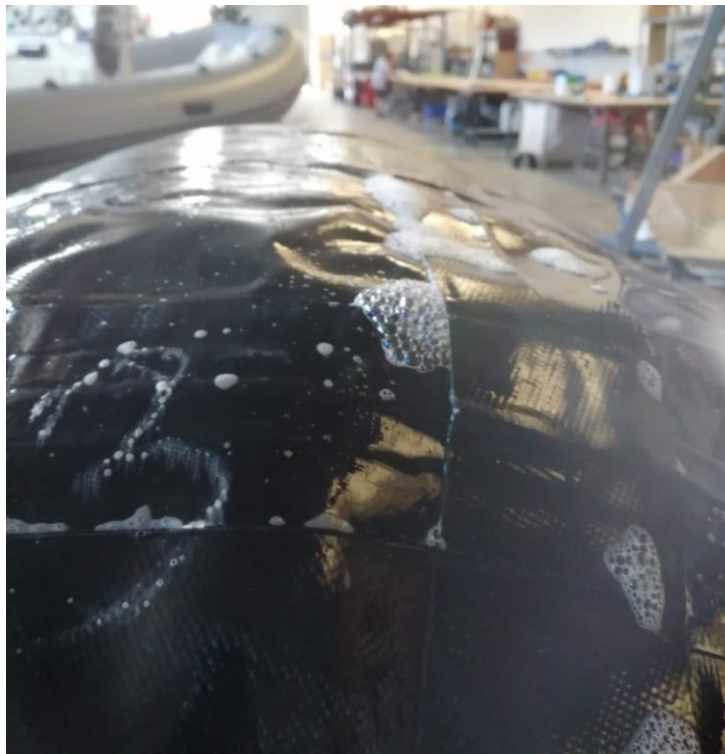
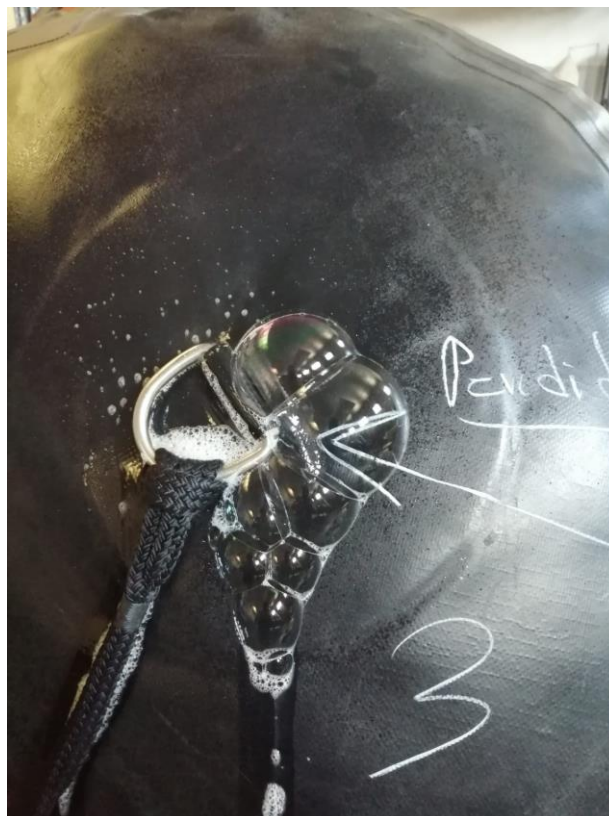
Fender 3 (Diameter 90 x 95cm) – Bad conditions, air leaking through glued seams

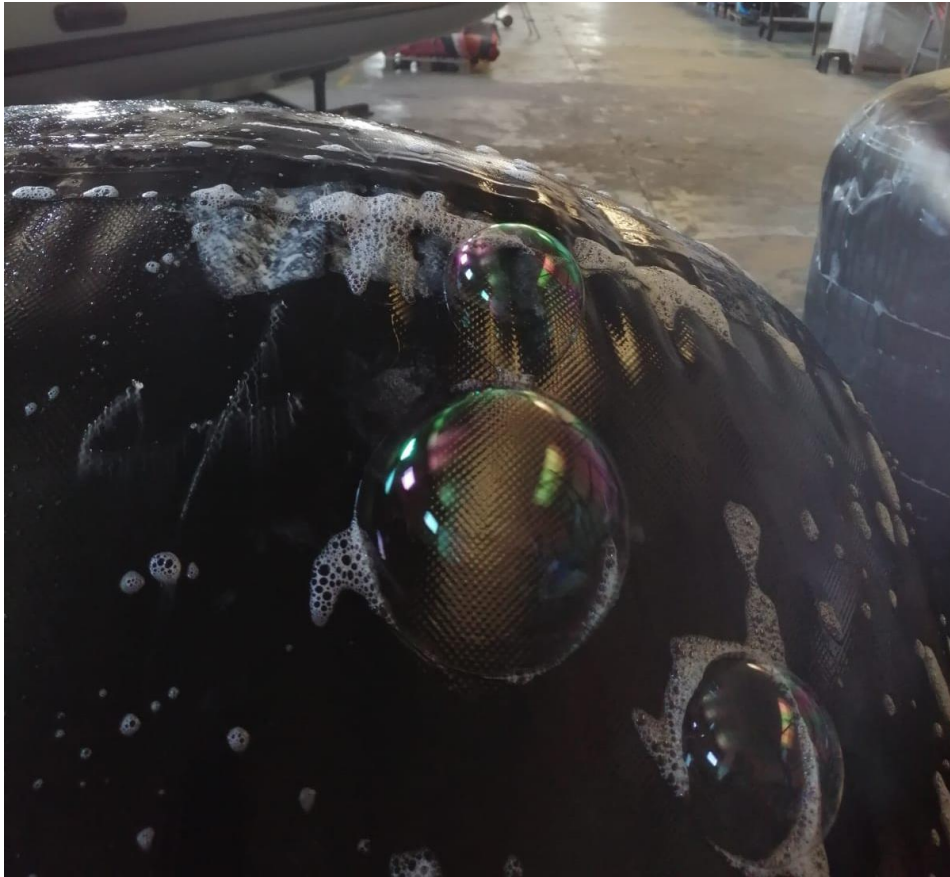
Fender 4 (Diameter 90 x 95cm) – Bad conditions, air leaking through glued seams

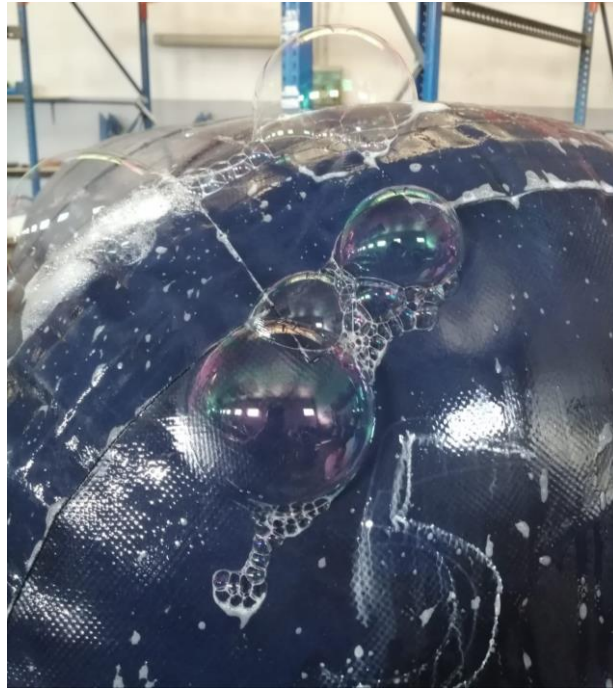
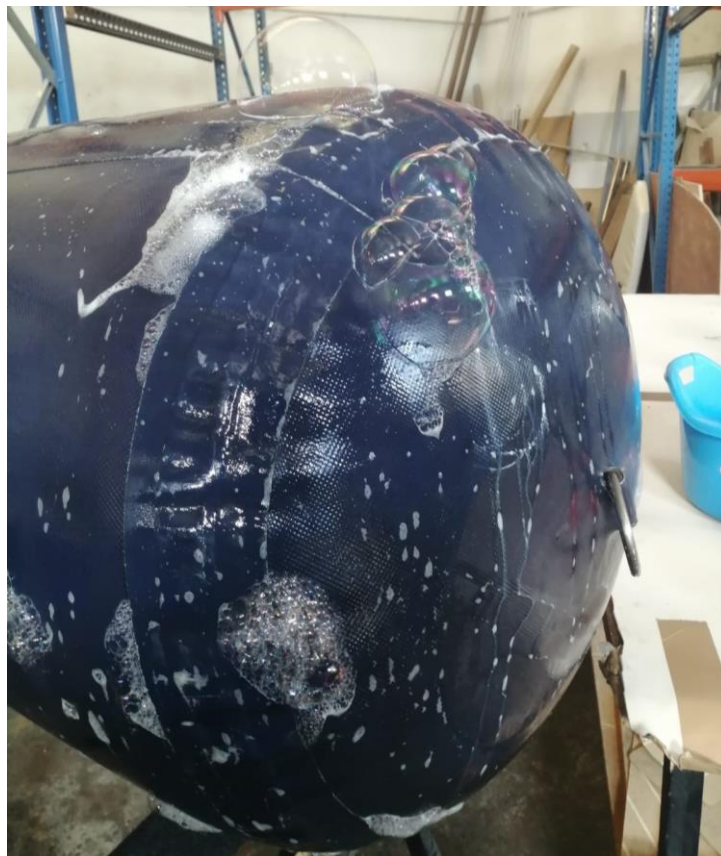
Fender 5 (Diameter 62 x 122cm) – Bad conditions, air leaking through glued seams

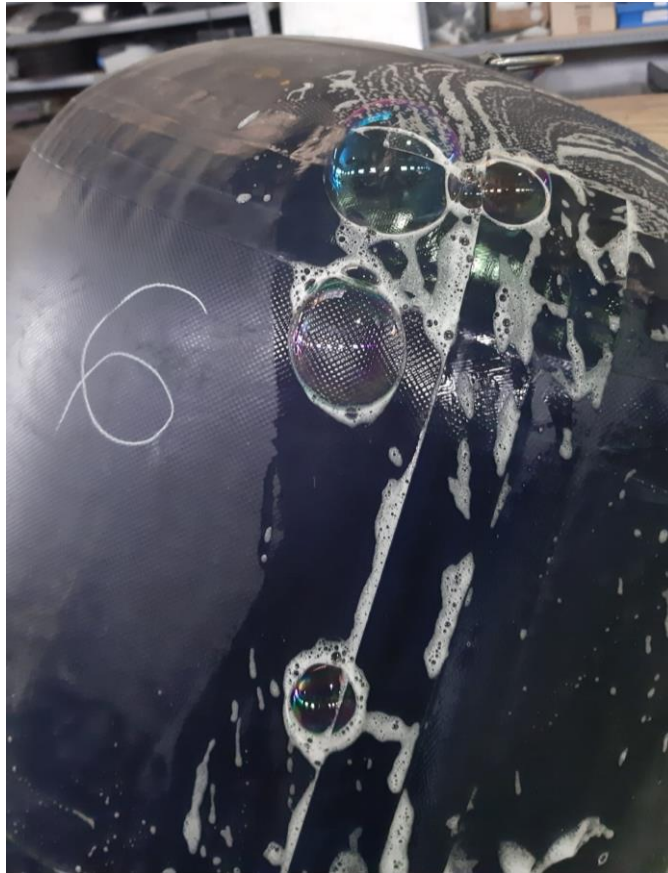
Fender 6 (Diameter 62 x 122cm) – Bad conditions, air leaking through glued seams
