INSPECTION REPORT

MY STELLA MARIS

21073

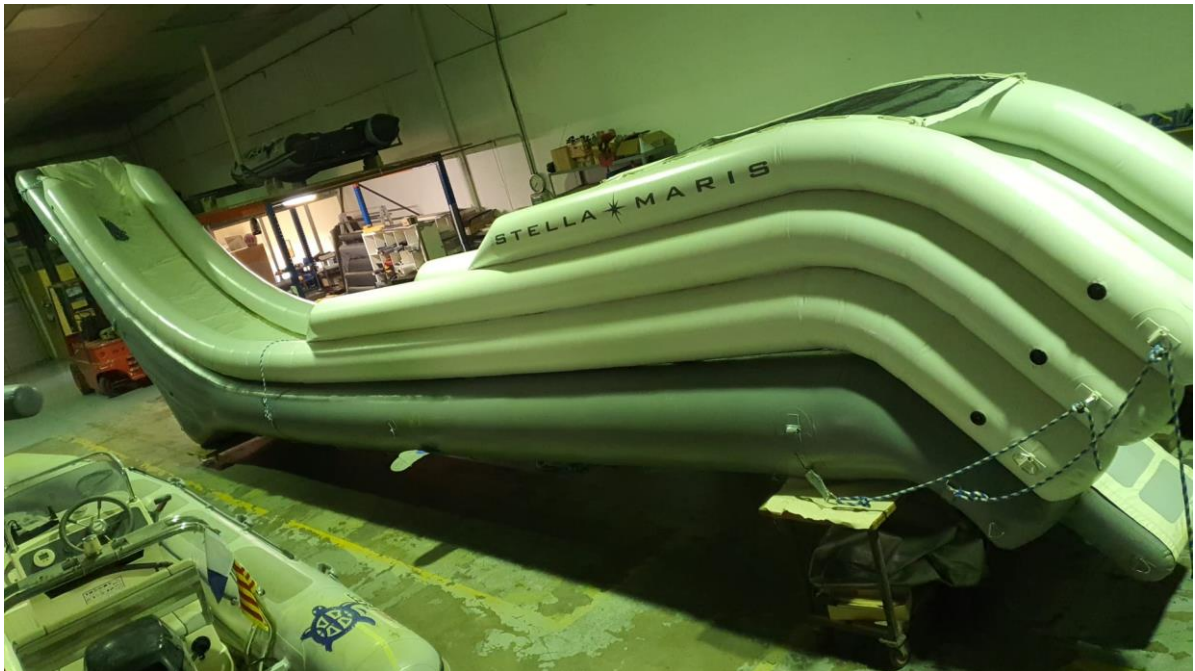
PVC strip totally detached approximately 180cm from main tube.

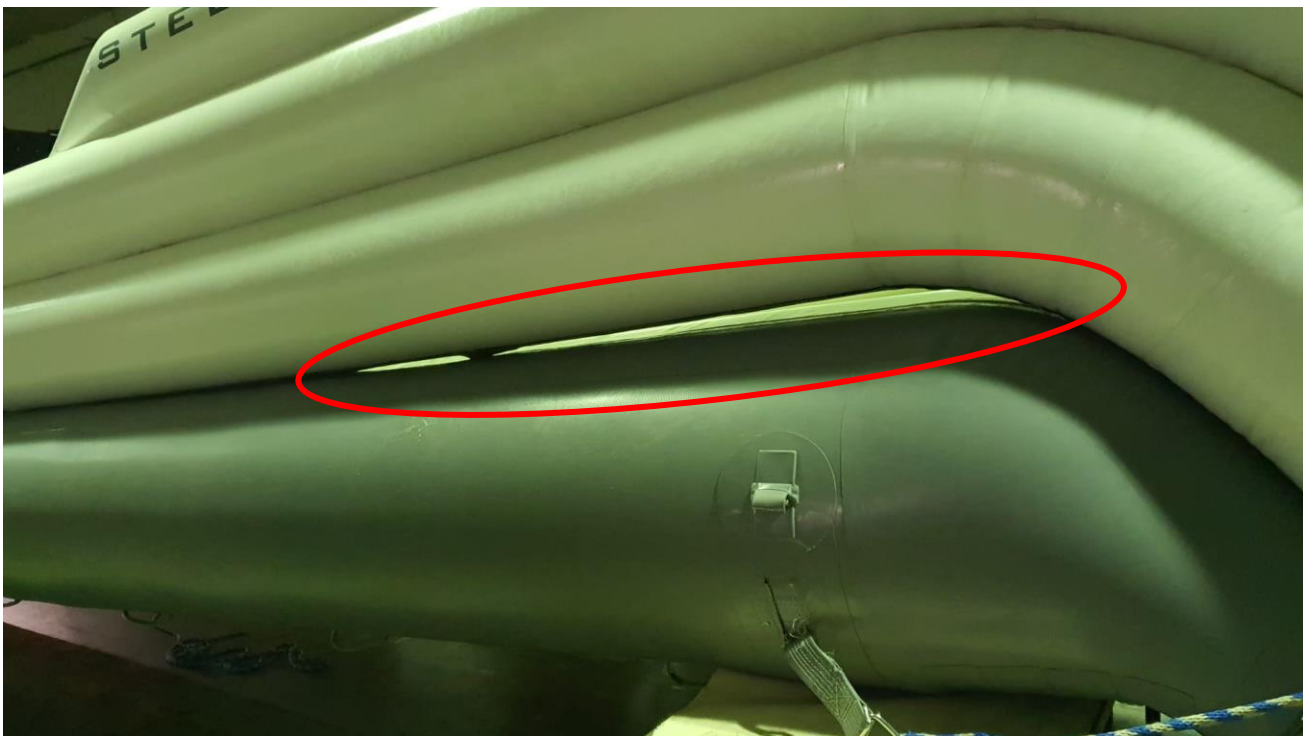
Additional 220cm partially detached. The proposed reparation solution is to reglue the opened areas and reinforce with additional strip 4-5cm width along a total length 500cm up to the end on the top side.

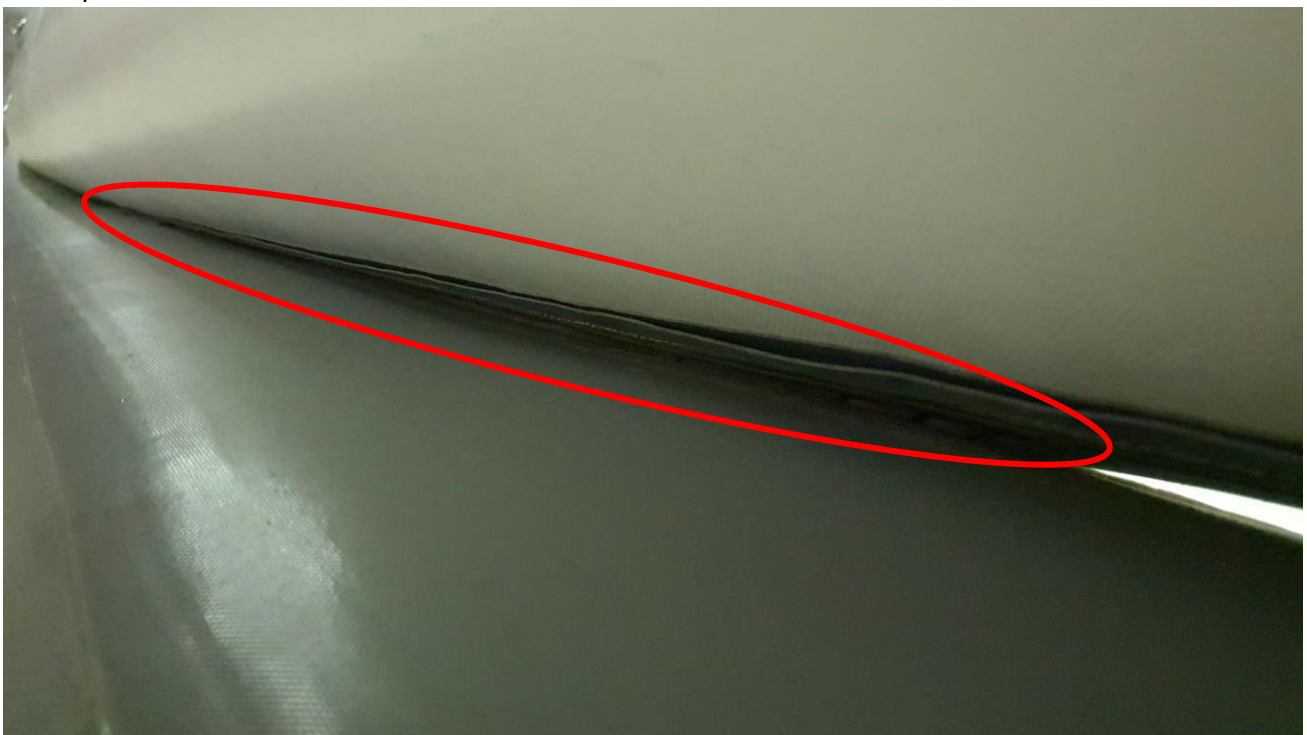
Refit D-Ring ripped off on the top part of the slide and reinforce the area with new PVC material same colour.

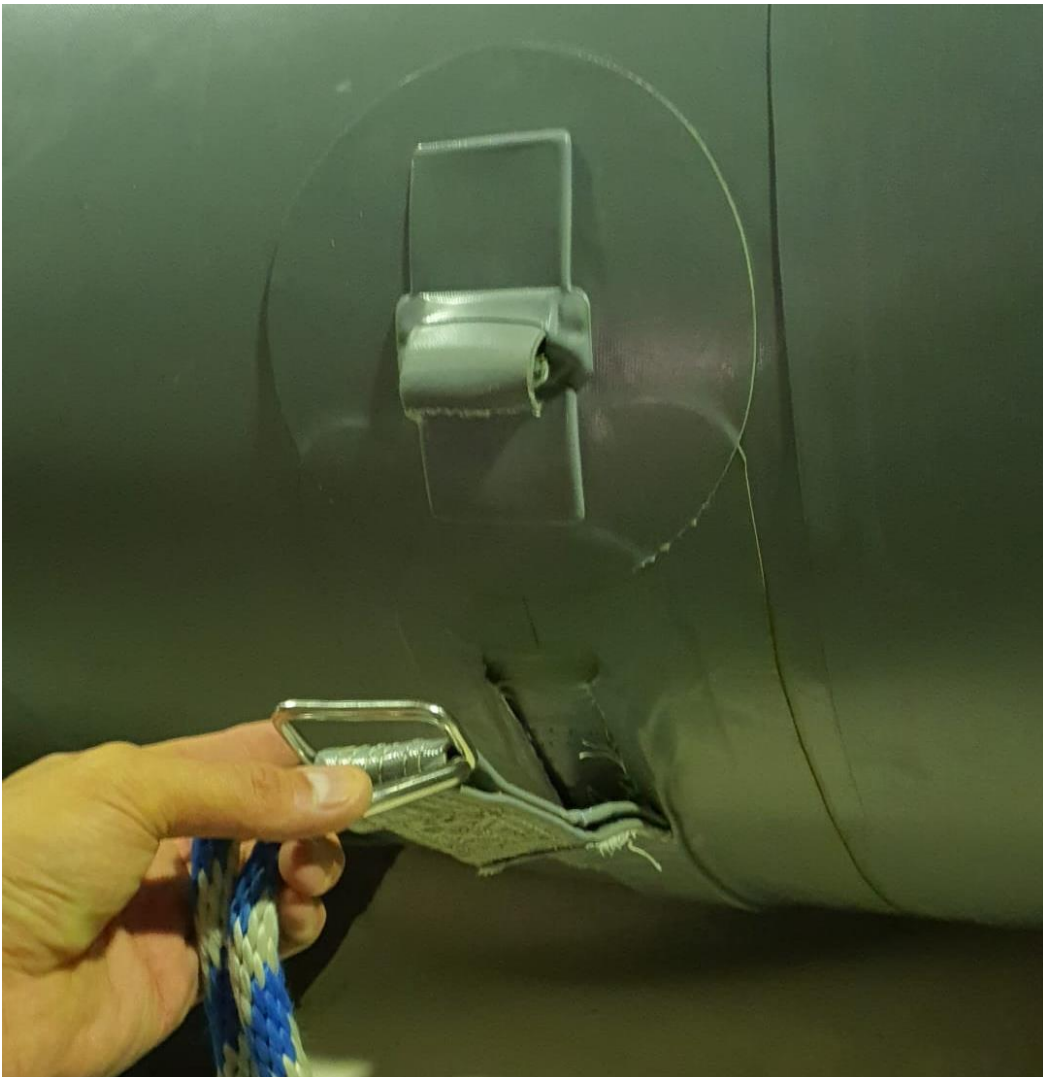
Reglue 3 lifting eyes patches coming off on side main section tube and reinforce the area with new PVC material same colour.

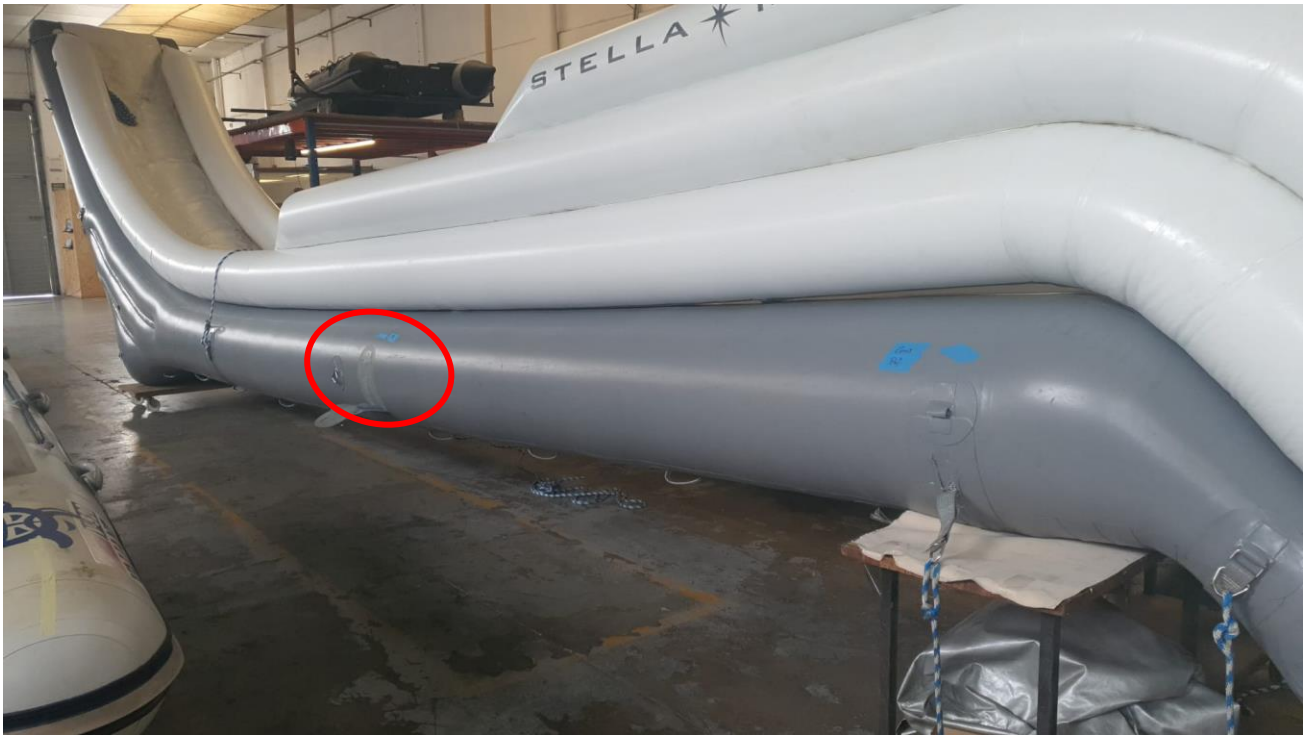
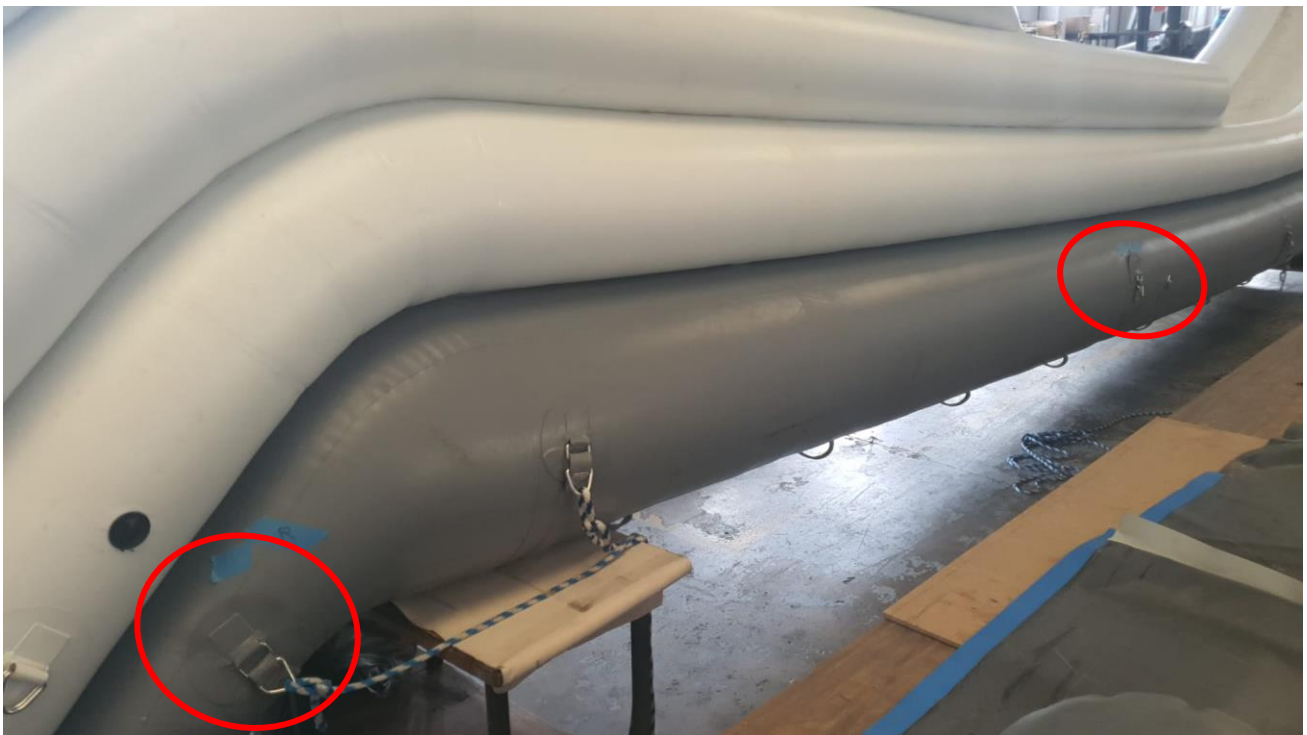
Reparation of small peelings on PVC patches & accessories, included on the pressure test and inspection service.
